Vehicle-activated signs – a large scale evaluation

Prepared for Road Safety Division, Department for Transport

M A Winnett and A H Wheeler

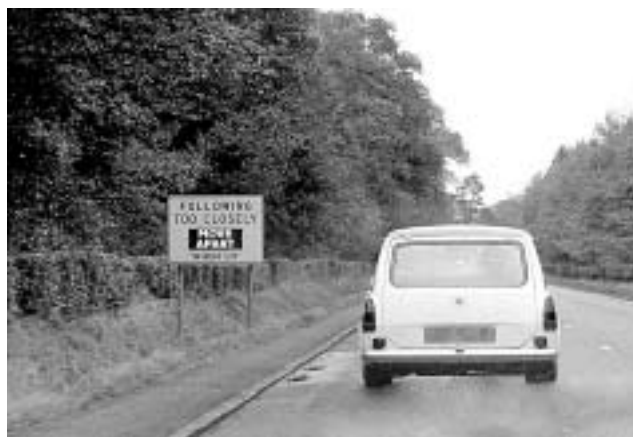
The sign advising drivers to 'MOVE APART' (Plate 1) was constructed using a back-lit message and relied on an overhead infra-red detector to measure the separation of the close following vehicle from the vehicle in front.

Plate 1 Close following sign

The close following sign was trialled on the A332 at Ascot, Berkshire (Helliari-Symons, 1983) and the speed limit speed warning signs were trialled in Hampshire on the A32 (now B3349) at West Meon and Droxford, where conventional accident countermeasures had not been entirely successful (Helliari-Symons *et al.*, 1984).

- The close following sign reduced by about 30% the number of drivers following the vehicle in front with a gap of less than one second.
- The effect was maintained 800m downstream.
- There was no appreciable degradation of the effectiveness of the close following sign over a five-year period.

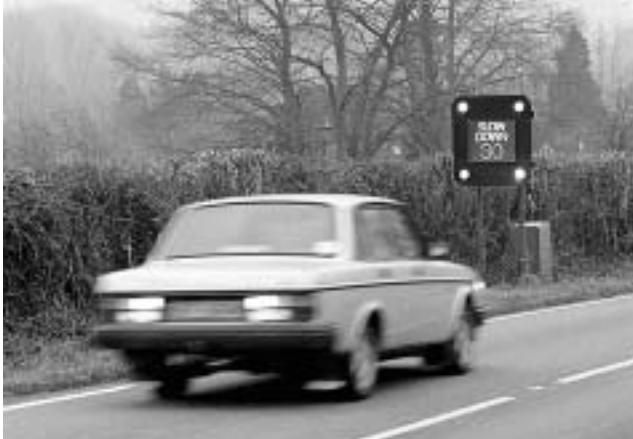
The sign advising drivers to ‘SLOW DOWN’ (Plate 2) had a message formed by a number of pinpoints of light individually supplied through fibre-optic cables. The vehicle speed was measured from inductive loops buried in the carriageway. The original ‘SLOW DOWN PLEASE’ message was later amended to ‘SLOW DOWN 30’.

Plate 2 Speed reduction sign

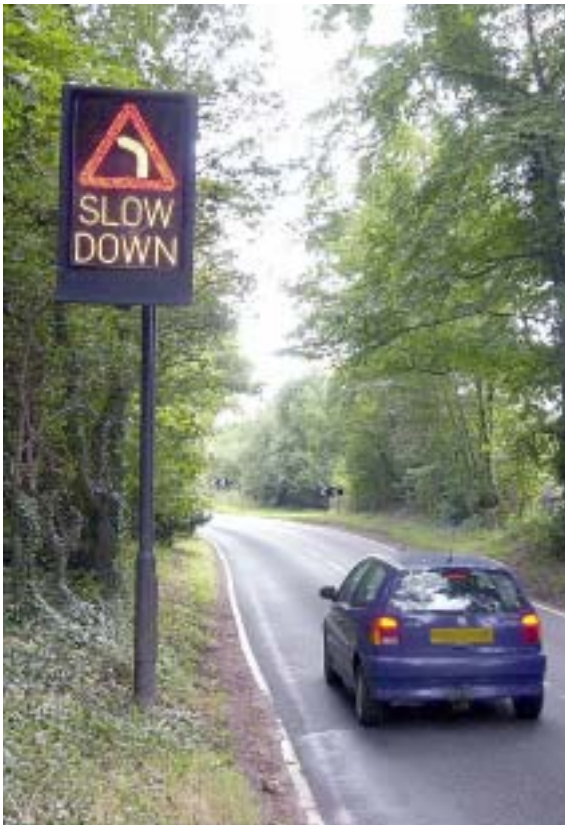
With the exception of the rural bend sign (Felbrigg, Norfolk) that was activated from a buried inductive loop, the other signs were activated by microwave detector

Plate 3 Felbrigg bend, Norfolk

heads (X-band 10.5Ghz) mounted on the top of the signs. These heads were aligned to detect vehicles at a distance of 100-150m in advance of the signs.

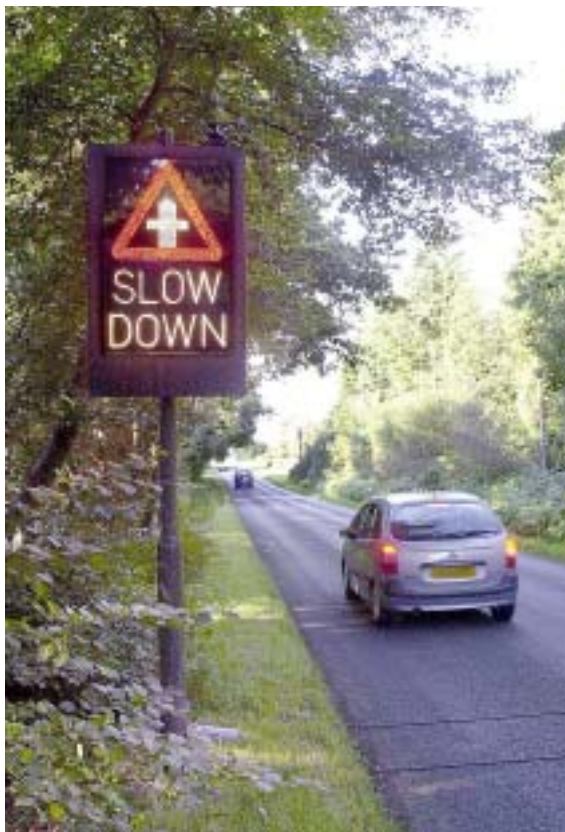
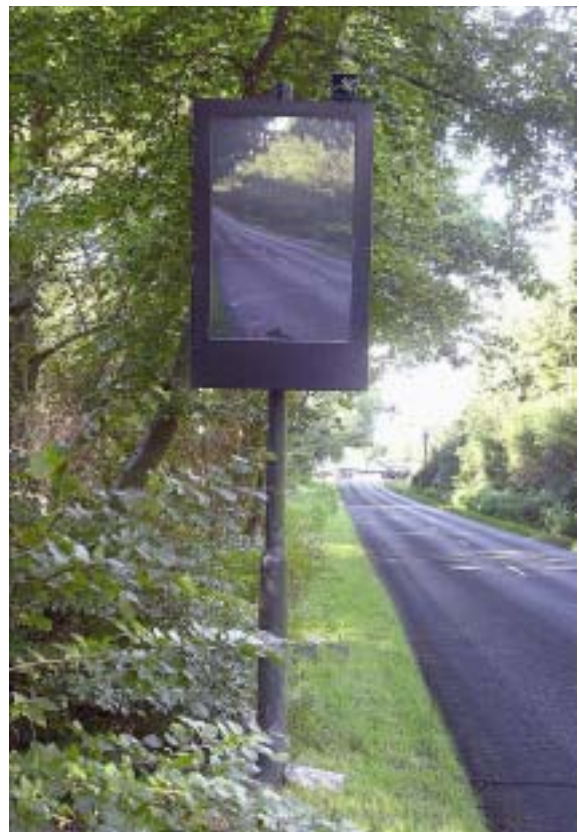
The signs were switched on for 4 seconds when a vehicle exceeding the threshold was detected. This exposure time was calculated to be sufficient for the driver to register and understand the message. As a rule, the distance between the sign and the position at which the vehicle is detected, can be calculated from the distance travelled in 3 seconds at the 85th percentile speed. The time of 3 seconds was chosen because it was found that almost all drivers (99.9%) should be able to read a sign consisting of N words in $N/3 + 2$ seconds (Moore *et al.*, 1963). This formula was derived from an experiment in which subjects had to identify a specific place name on a sign displaying a number of unrelated names. It was assumed that in the case of meaningful phrases such as speed warning messages, they would be read more quickly, hence the minimum exposure of 3 seconds to the message. The character height was 200mm on all signs (with a warning triangle height of 600mm and a total sign height of 1200mm).

The threshold speed, at which the vehicle-activated warning signs were switched on, was set at the 50th percentile speed detected at the sign location before the sign was installed. This was to avoid excessive exposure to the sign by targeting half of the drivers. The speed roundel signs did not necessarily have a threshold speed set at the actual speed limit, but rather it was based on road conditions.

Plate 4 Felthorpe junction, Norfolk showing the sign on and off

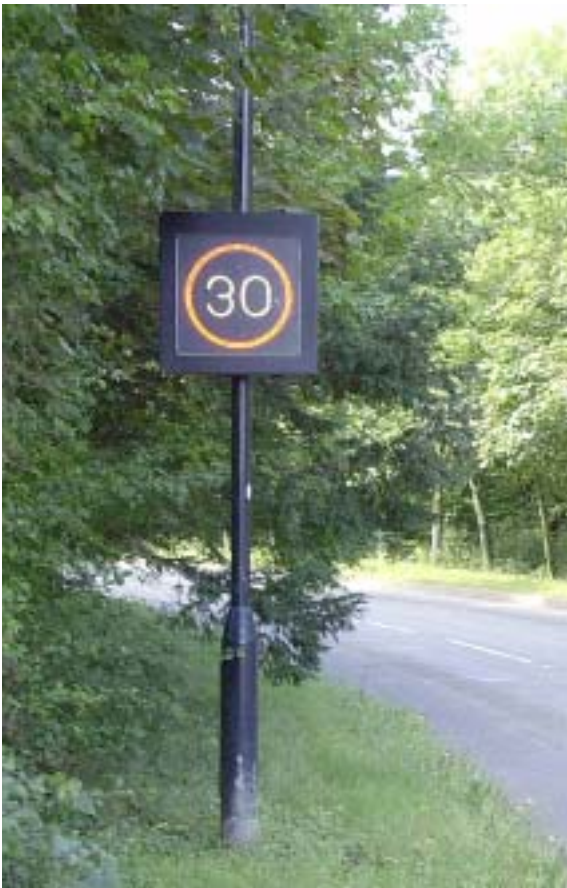
Vehicle-activated speed roundel signs are not repeater signs since they will only operate for drivers exceeding the speed limit. Consequently they do not display to all traffic. Their purpose is to reinforce the posted speed limit. Speed limit roundels were installed between 20 metres and 50 metres beyond the first sign indicating the change in the speed limit. For example, on a section with a 30mph limit, the vehicle-activated sign would be situated within this speed limit, 20-50 metres downstream from the speed limit terminal sign.

Plate 5 30 roundel without flashers (Brisley, Norfolk)

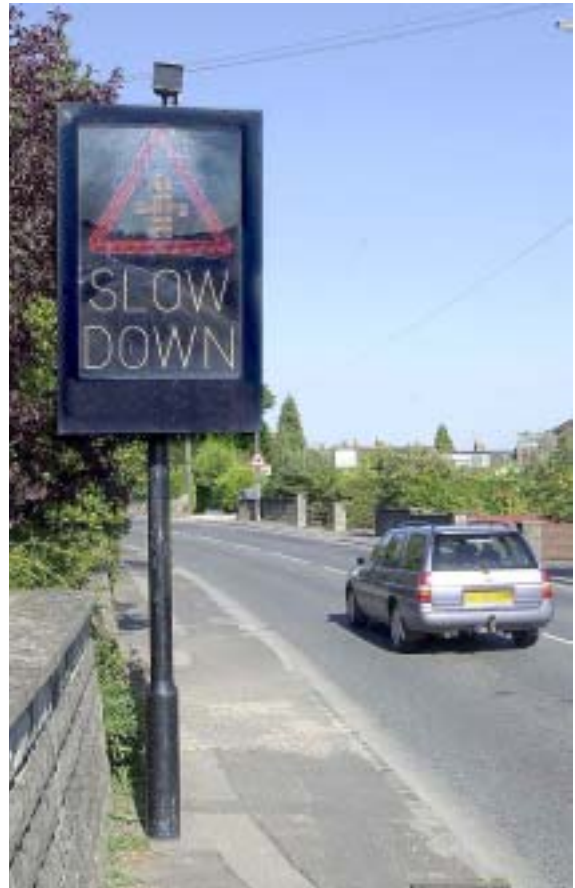
It is not always possible to reduce speed limits over a short distance where there is a hazard related to speed and this highlights the fact that speed limits are often inflexible. The junction warning signs are designed to deal with this particular problem. These signs have been located between 100 metres and 150 metres from the centre of the junction.

Plate 7 Junction warning sign (Wootton Bassett, Wiltshire)

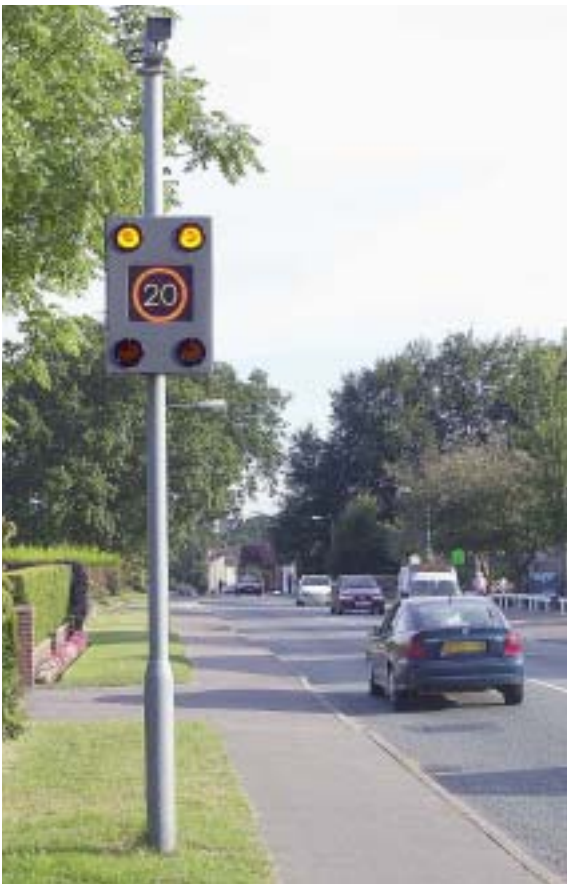
Plate 6 20 roundel with amber flashers (Horsford, Norfolk)

The signs in Kent and some in Norfolk were complemented by pairs of flashing amber lights that are triggered at the same time as the sign itself.

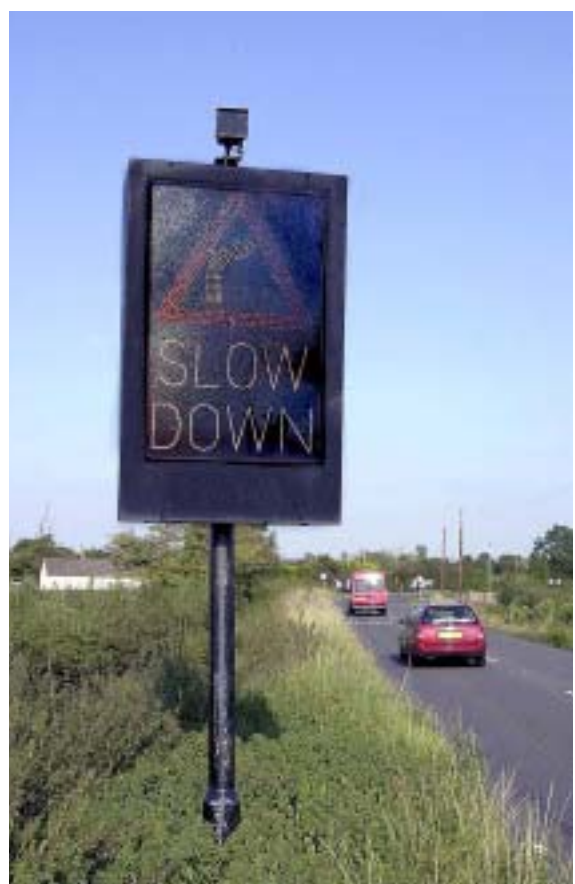
A major contributory factor reported by the police in bend accidents is excessive speed for the conditions. The bend signs were developed to deal with the problem of accidents involving loss of control due to excessive speed on the approach to bends. Many of these accidents are also associated with wet roads where tyre adhesion is reduced. This highlights the problem that drivers do not always take into account the prevailing conditions and adapt their behaviour accordingly. It is possible that since many of these accidents occur on minor roads, with a high proportion of local traffic, over-familiarity with the route and lack of concentration may be additional contributory factors. The signs give advance warning of the hazard, to reinforce the potential risk associated with the bend. These signs were located between 50 and 100 metres in advance of the apex of the bend.

Plate 8 Bend warning sign (Sells Green, Wiltshire)

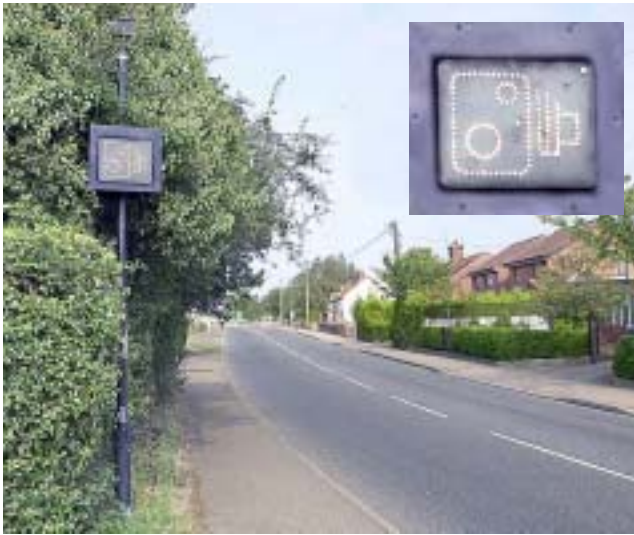
Plate 9 Safety camera logo (Poringland, Norfolk (detail inset))

The safety camera signs were developed to provide drivers with information that the route that they are on has had safety cameras installed to enforce the speed limit. Safety cameras do not provide drivers with the immediate feedback that they are offending and the signs were developed to provide this additional information to the driver. These signs were located between 50 and 150 metres inside the speed limit that was being enforced by safety cameras.
