Evaluation of Dynamic Speed Feedback Signs on Curves: A National Demonstration Project

PUBLICATION NO. FHWA-HRT-14-020

JANUARY 2015

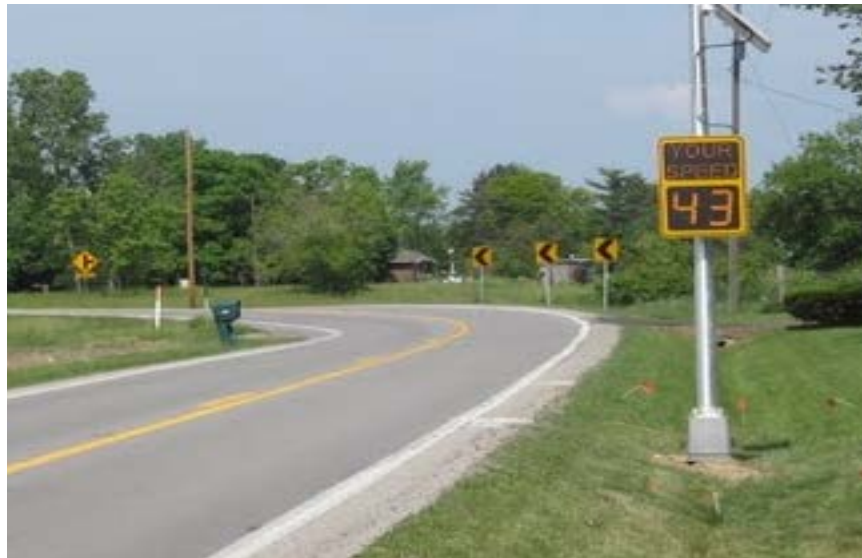
Figure 1. Photo. Speed display sign used in study.

Figure 1 shows one type of sign displaying vehicle speed (referred to as the speed display sign), and figure 2 shows the other displaying a curve warning sign (referred to as the curve display sign).

Both signs activate when drivers exceed the 50th percentile speed. The speed sign displays the vehicle's actual speed, up to a certain threshold, and then the speed indication is replaced by the actual posted speed limit. The threshold was selected to avoid drivers using the sign to test their speeds above the threshold.

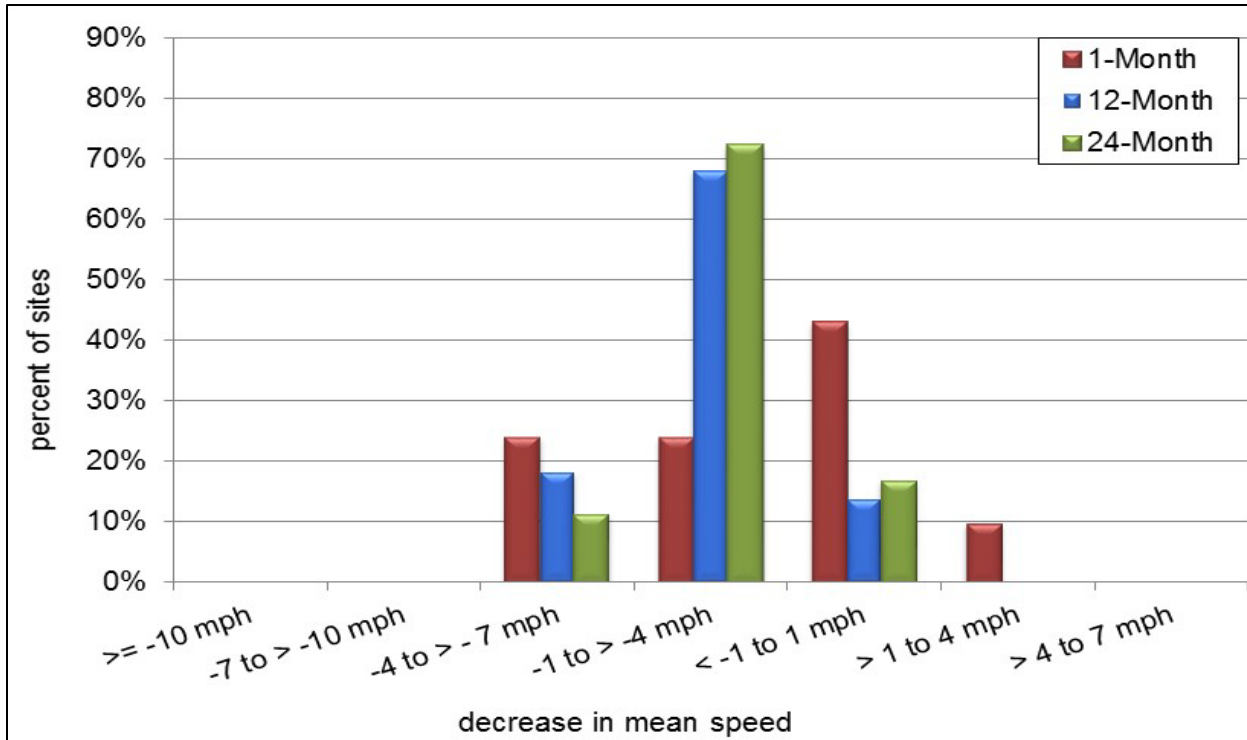
Figure 3. Chart. Percent of sites experiencing a change in mean speed of a certain magnitude at the PC.

Decreases in mean and 85th percentile speeds were plotted to show the distribution of change. Figure 3 shows the percent of sites experiencing decreases in mean speeds of a certain magnitude at 1, 12, and 24 months. Figure 4 provides changes in 85th percentile speeds of a certain magnitude.

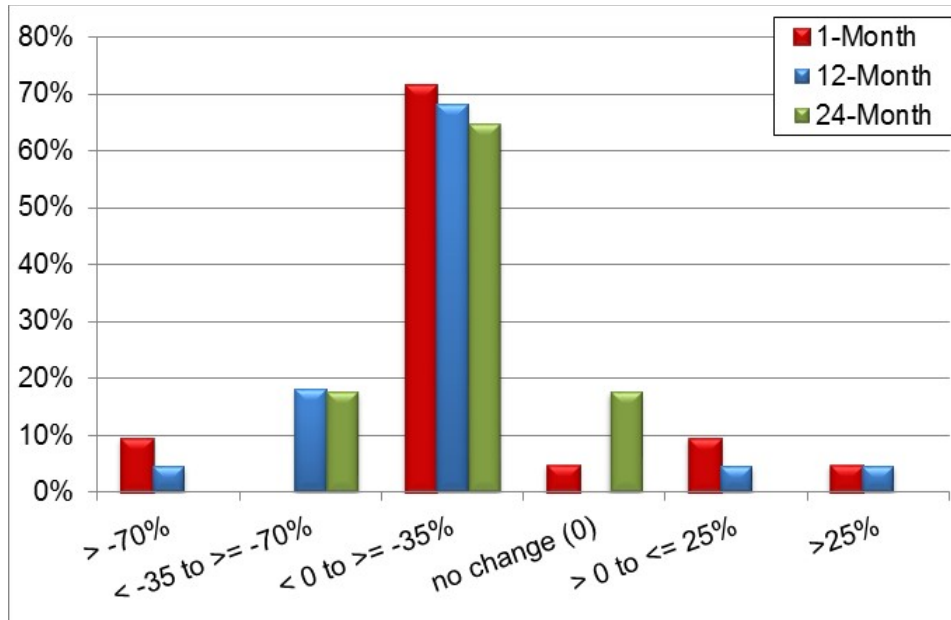
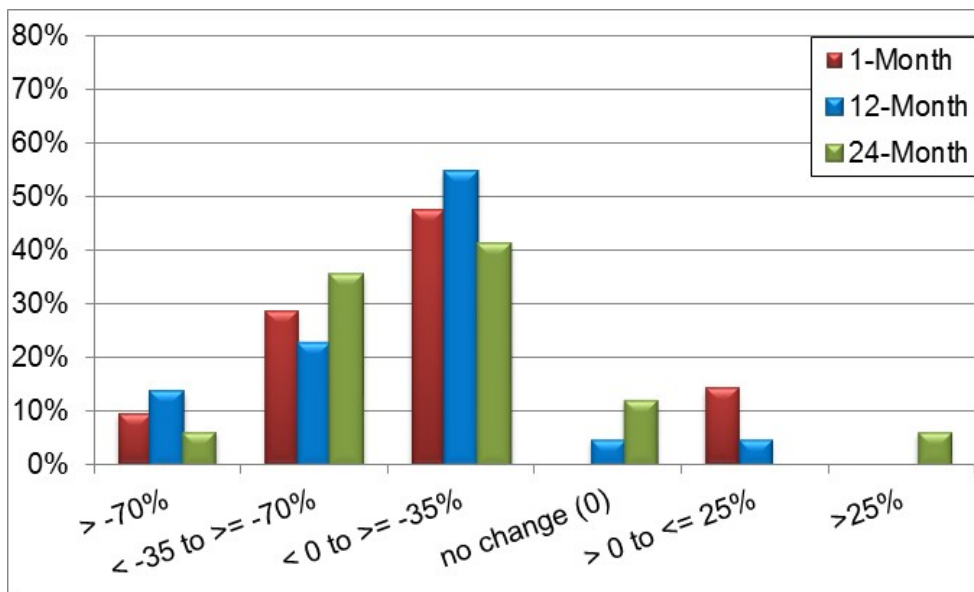
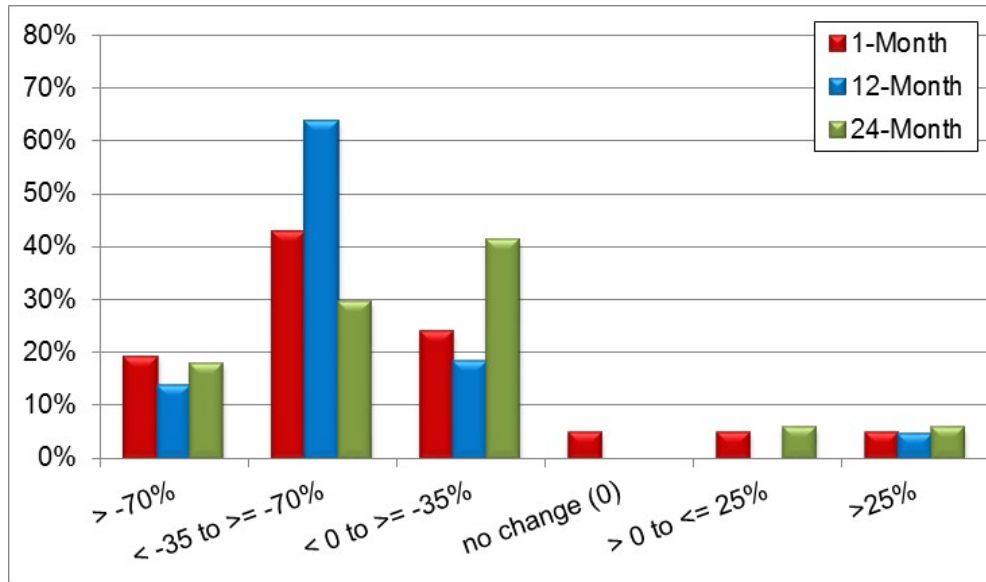
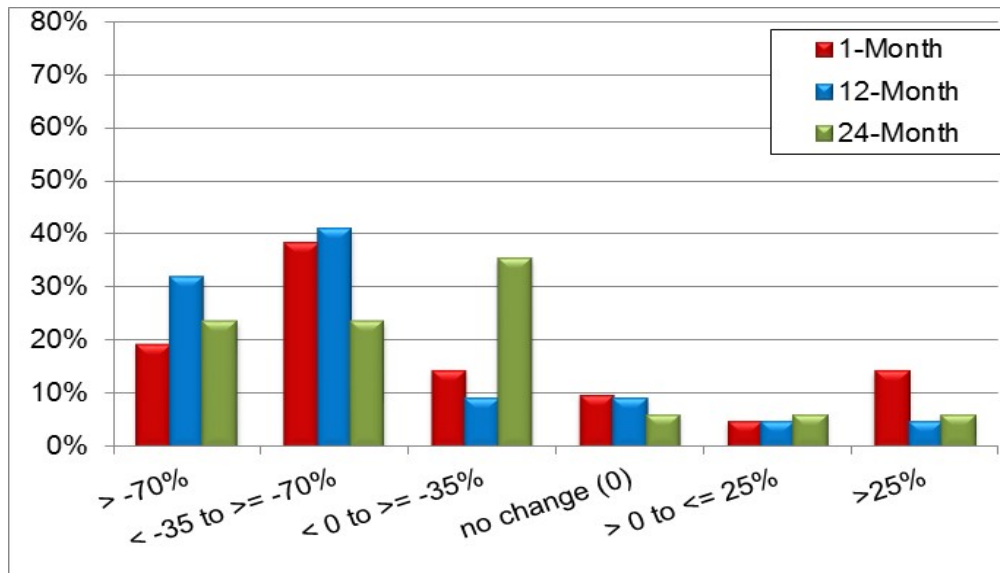
Figure 5 through figure 8 show changes in the percent of vehicles traveling 5 mph or more, 10 mph or more, 15 mph or more, and 20 mph or more, respectively, over the posted speed or advisory speed at the PC. Researchers used advisory speed if present; if not present, the posted speed limit was used. Figure 5 shows the percent of sites with a change at a particular magnitude. For instance, the first interval is the percent of sites that had decreases of 70 percent or more in the number of vehicles traveling 5 mph or more over the posted or advisory speed.

Figure 5. Chart. Changes in percent of vehicles traveling 5 or more mph over posted limit or advisory speed at the PC.

Figure 6. Chart. Changes in percent of vehicles traveling 10 or more mph over posted limit or advisory speed at the PC.

Figure 7. Chart. Changes in percent of vehicles traveling 15 or more mph over posted limit or advisory speed at the PC.

Figure 8. Chart. Changes in percent of vehicles traveling 20 or more mph over posted limit or advisory speed at the PC.

As noted, significant reductions in the number of vehicles traveling over the posted or advisory speed occurred for all of the after periods at the PC. In most cases, the majority of sites had reductions between 35 and 70 percent in the fraction of vehicles exceeding the posted or advisory speed. This was the case for all of the speed thresholds (5, 10, 15, and 20 mph or more over). In addition, reductions of greater than 70 percent were noted for all time periods and thresholds except for one. This indicates the signs were effective in reducing high-end speeds, as well as average and 85th percentile speeds.

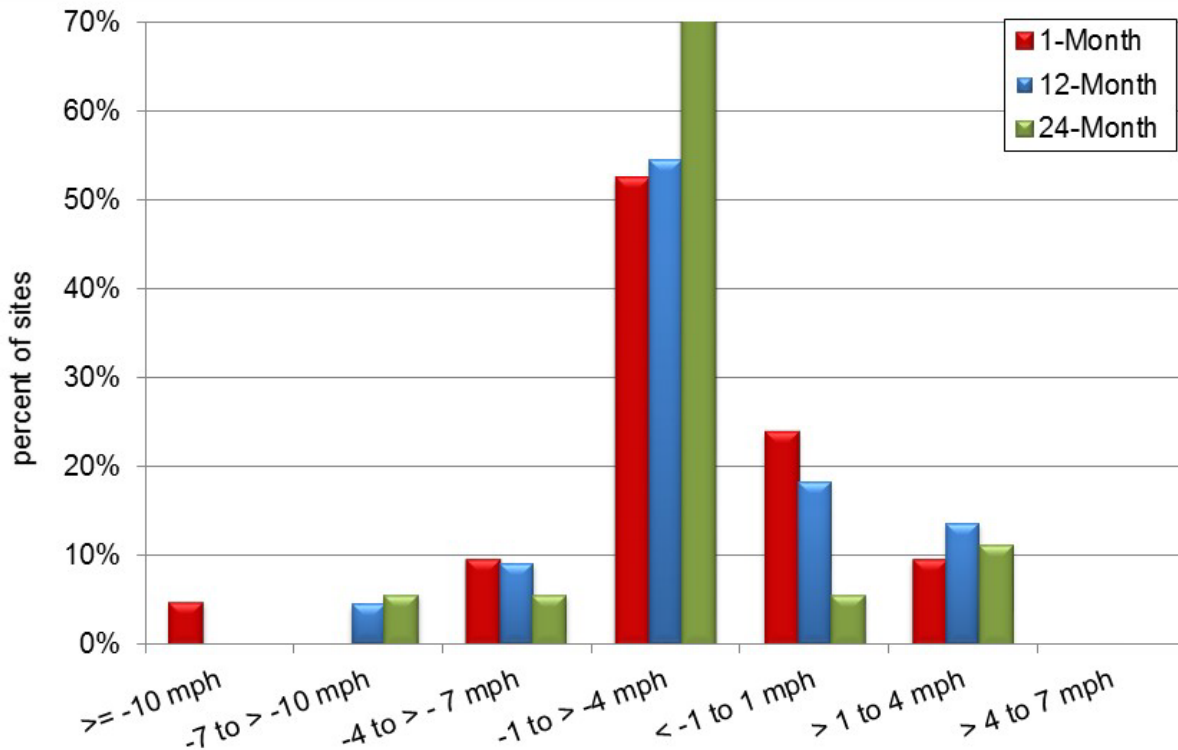
Figure 9. Chart. Percent of sites experiencing a change in mean speed of a certain magnitude at the CC.

The following figures show the distribution of results. Figure 9 shows the percent of sites experiencing changes in mean speeds of a certain magnitude. As indicated, the majority of sites had decreases in mean speeds from 1 to 4 mph.

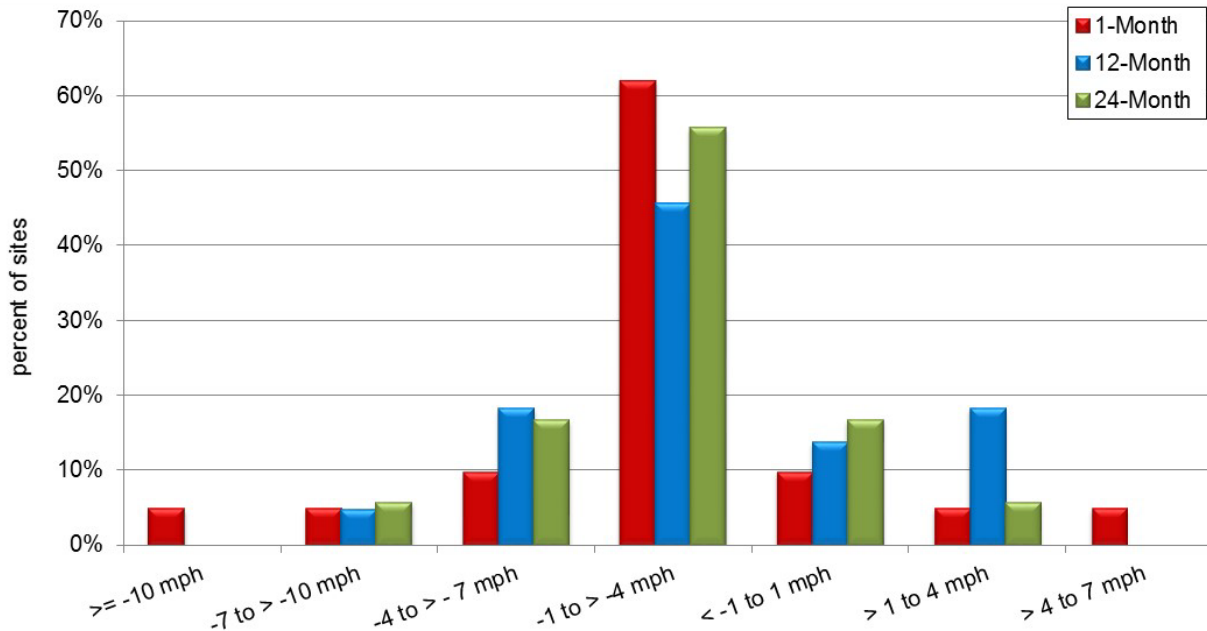
Figure 10. Chart. Percent of sites experiencing a change in 85th percentile speed of a certain magnitude at the CC.

Figure 10 shows the changes in 85th percentile speeds at the CC at 1, 12, and 24 months. Overall, as indicated, the majority of sites for all after periods had decreases in mean speeds from 1 to 4 mph.

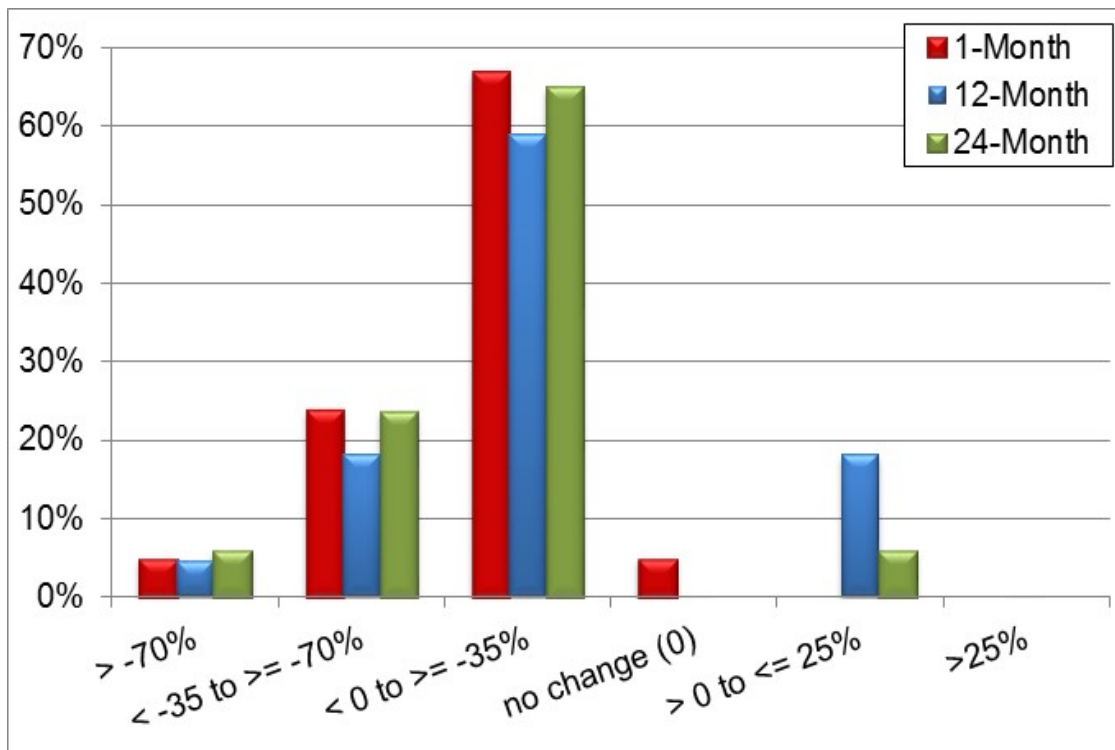
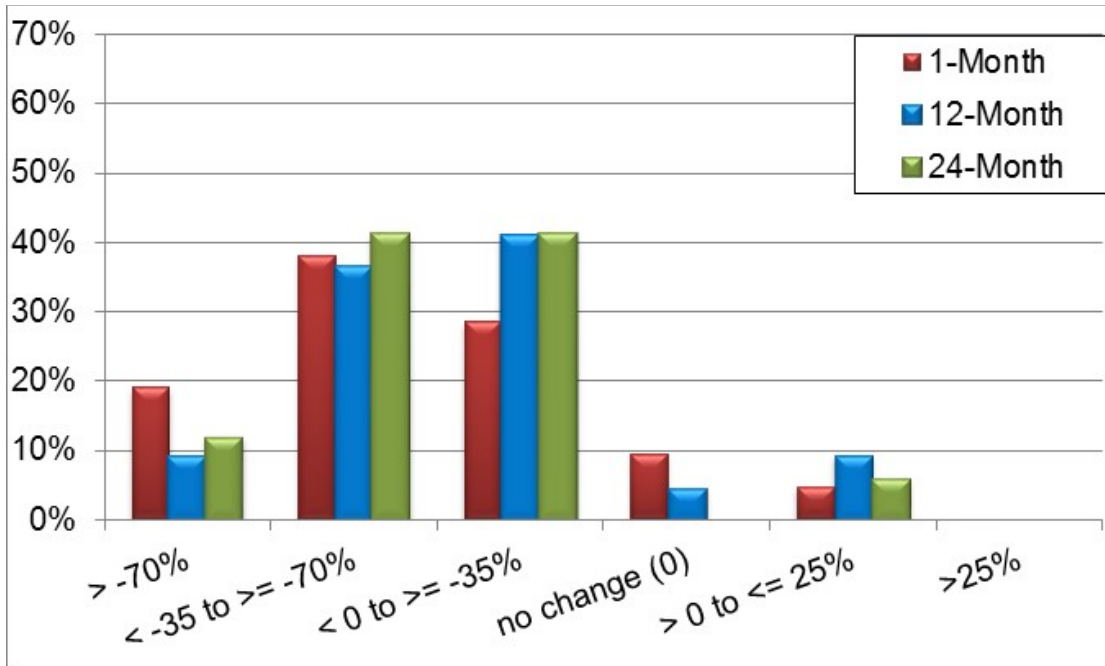
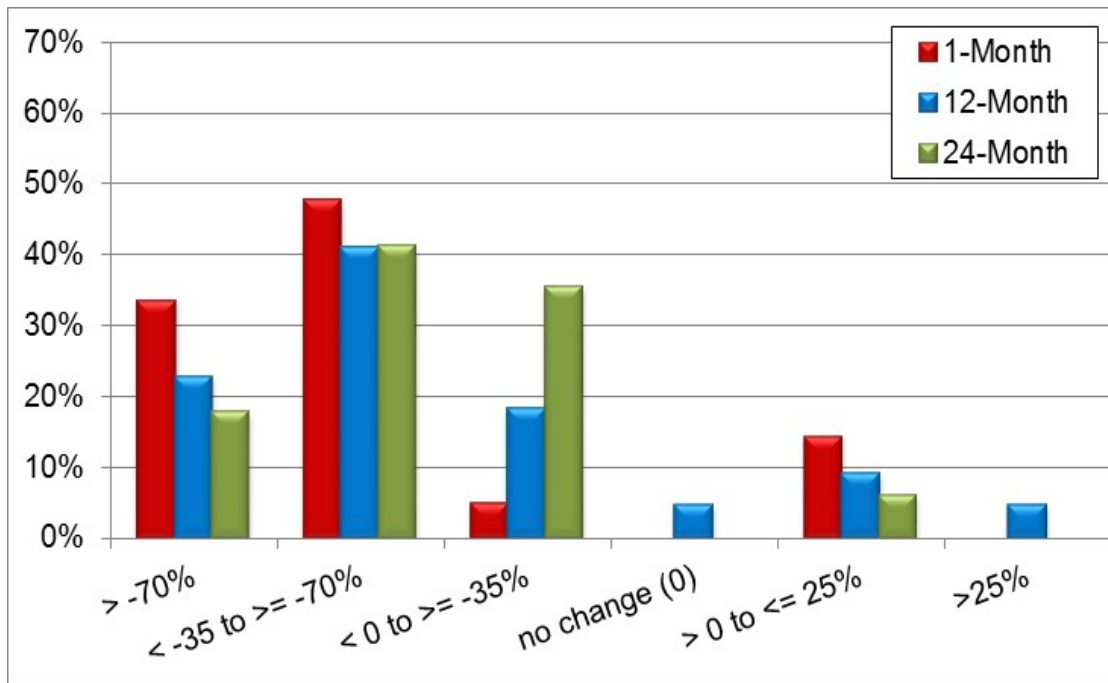
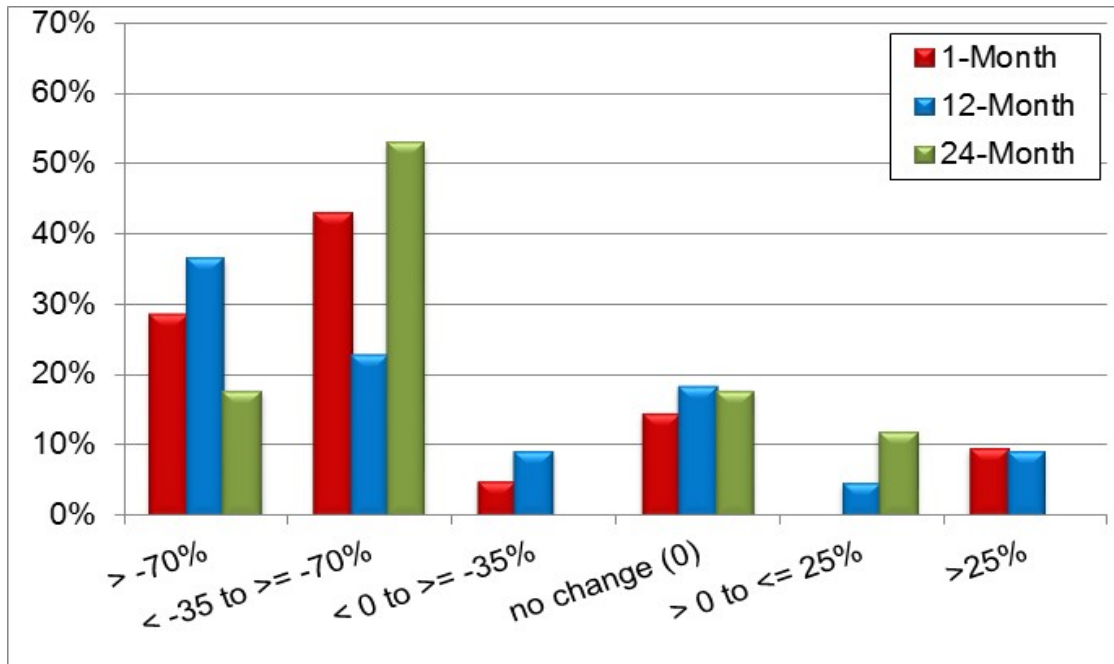
Figure 11 through figure 14 show changes in the percent of vehicles traveling at 5, 10, 15, and 20 mph or more over the posted speed limit or advisory speed at the CC. Each figure shows the percent of sites that experienced a change within a particular range. Data are fairly consistent over the 1-, 12-, and 24-month after periods.

Figure 11. Chart. Changes in percent of vehicles traveling 5 or more mph over posted limit or advisory speed at the CC.

Figure 12. Chart. Changes in percent of vehicles traveling 10 or more mph over posted limit or advisory speed at the CC.

Figure 13. Chart. Changes in percent of vehicles traveling 15 or more mph over posted limit or advisory speed at the CC.

Figure 14. Chart. Changes in percent of vehicles traveling 20 or more mph over posted limit or advisory speed at the CC.

As noted, large reductions in the number of vehicles traveling over the posted or advisory speed occurred for all of the after periods at the CC. The majority of sites had reductions up to 35 percent in the fraction of vehicles traveling 5 mph or more over the posted or advisory speed. The majority of sites had decreases up to 70 percent in the fraction of vehicles traveling 10 mph or more over the posted or advisory speed. Most sites had reductions of 35 percent or more in the fraction of vehicles traveling 15 or 20 mph or more over the posted or advisory speed. These results indicate the signs were effective in reducing high-end speeds as well as average and 85th percentile speeds.

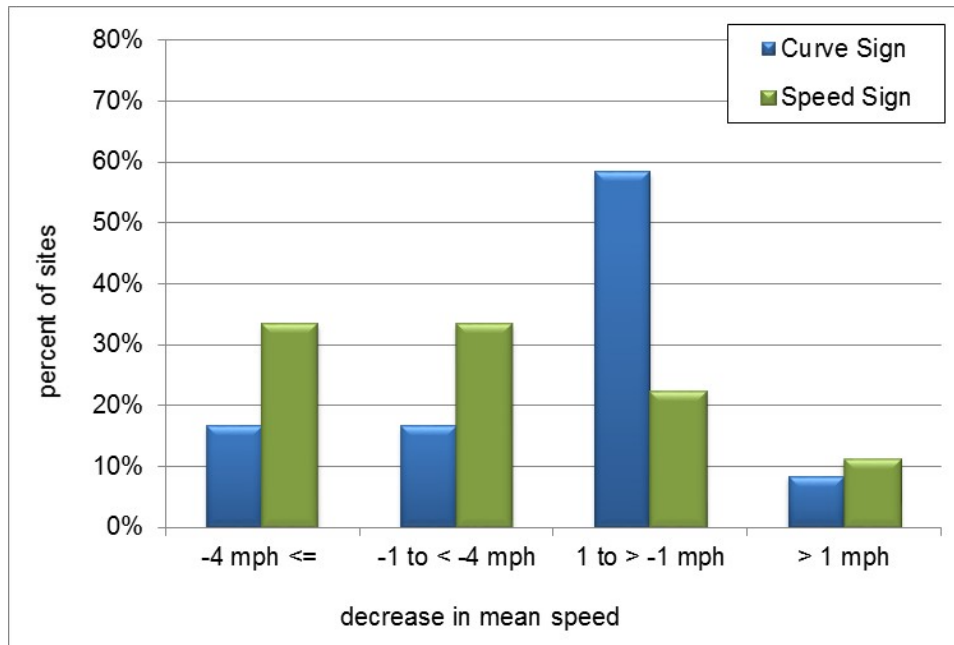
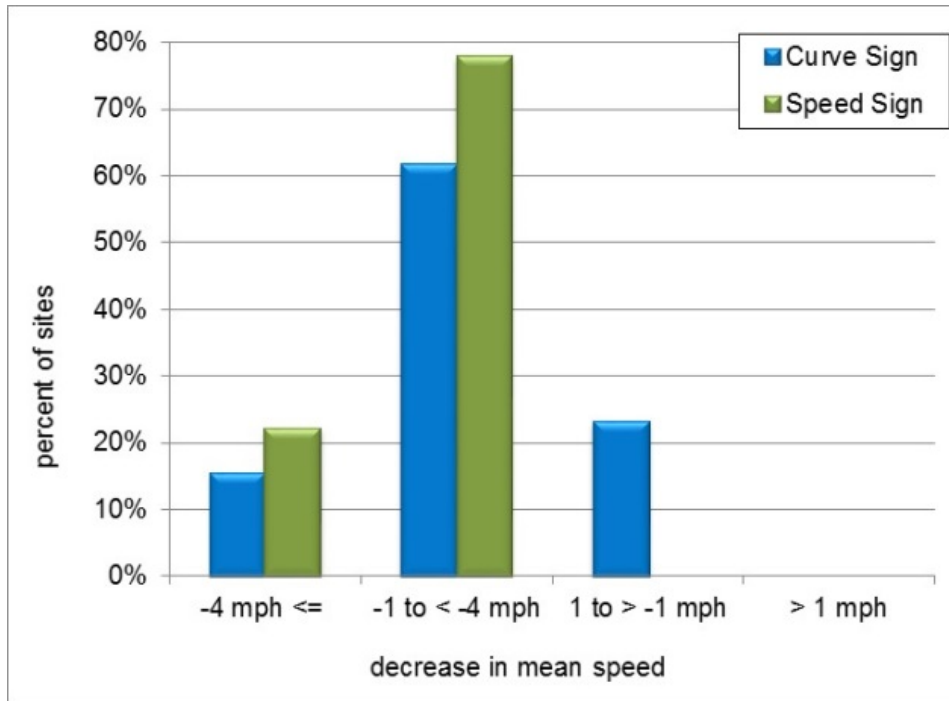
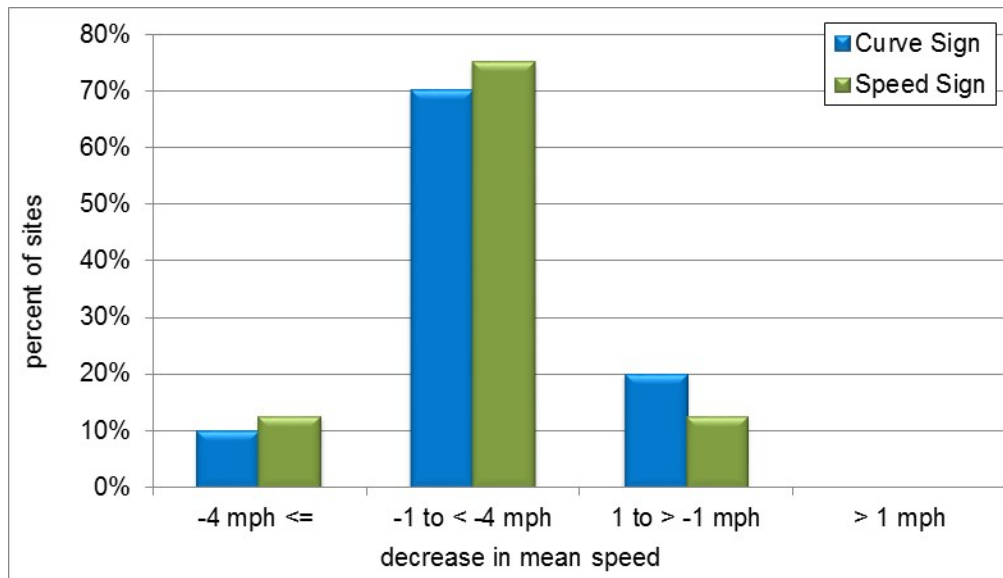
Results for the 24-month after period are very similar to those for the 12-month after period.

Figure 15. Chart. Changes in mean speed at the PC by sign type about 1 month after sign installation.

Figure 16. Chart. Changes in mean speed at the PC by sign type about 12 months after sign installation.

Figure 17. Chart. Changes in mean speed at the PC by sign type about 24 months after sign installation.

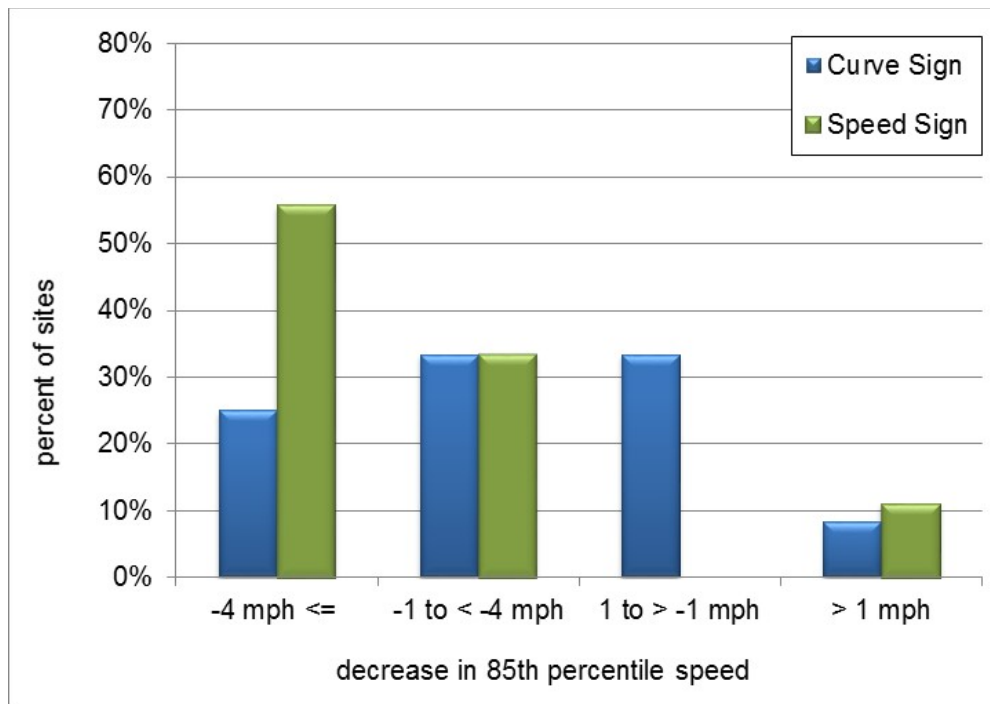
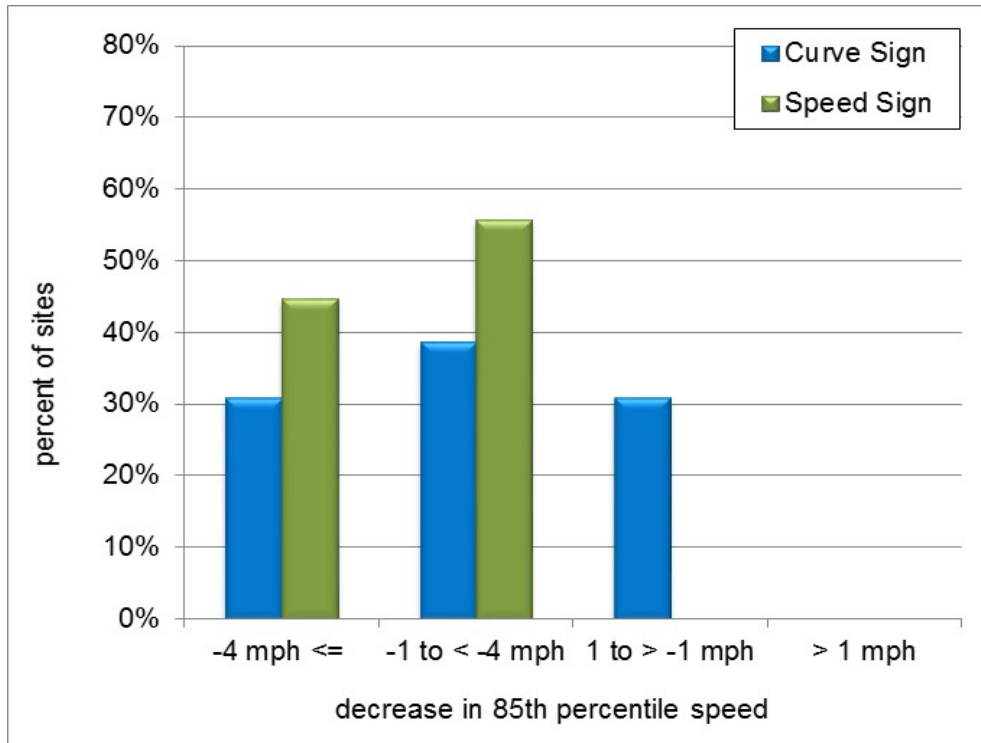
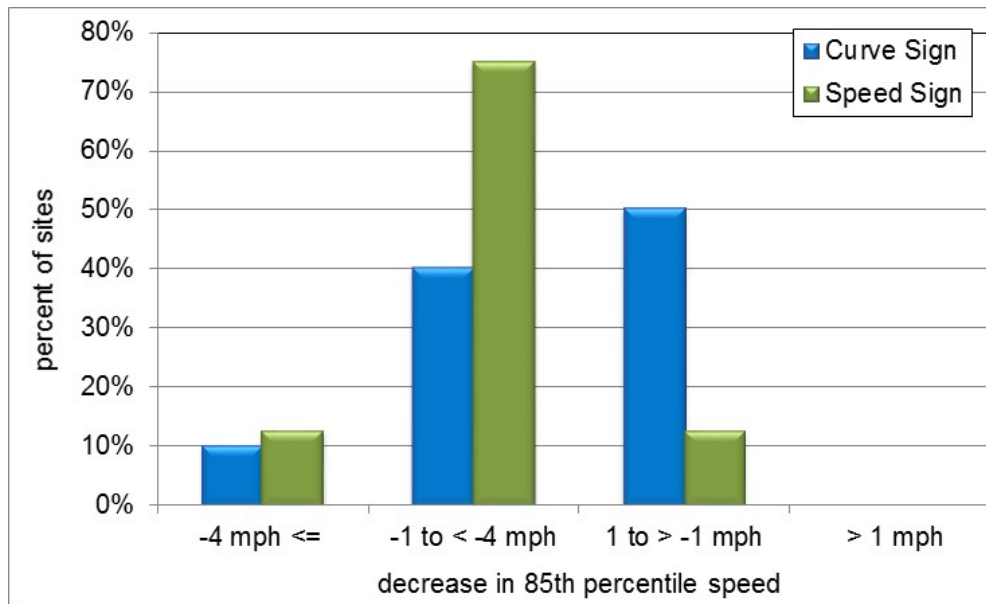
About 31 percent of sites with a curve sign showed little change in 85th percentile speeds. The majority of sites with both types of signs (38 percent of sites with curve signs and 56 percent of sites with speed signs) had decreases in 85th percentile speeds between 1 and 4 mph. Thirty-one percent of sites with curve signs and 44 percent of sites with speed signs experienced decreases in 85th percentile speeds of 4 mph or more.

Figure 18. Chart. Changes in 85th percentile speed at the PC by sign type about 1 month after sign installation.

Figure 19. Chart. Changes in 85th percentile speed at the PC by sign type about 12 months after sign installation.

Figure 20. Chart. Changes in 85th percentile speed at the PC by sign type about 24 months after sign installation.

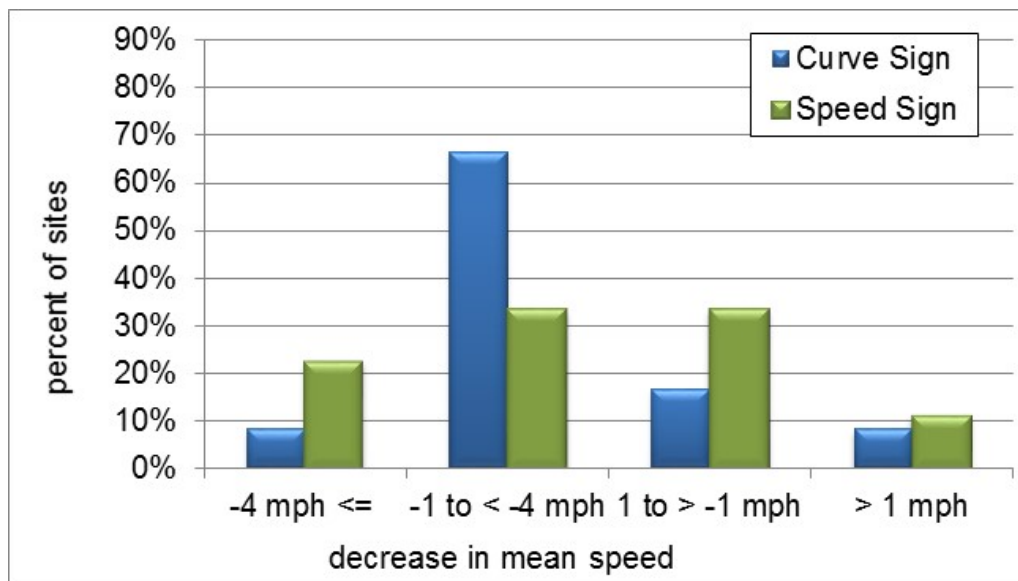
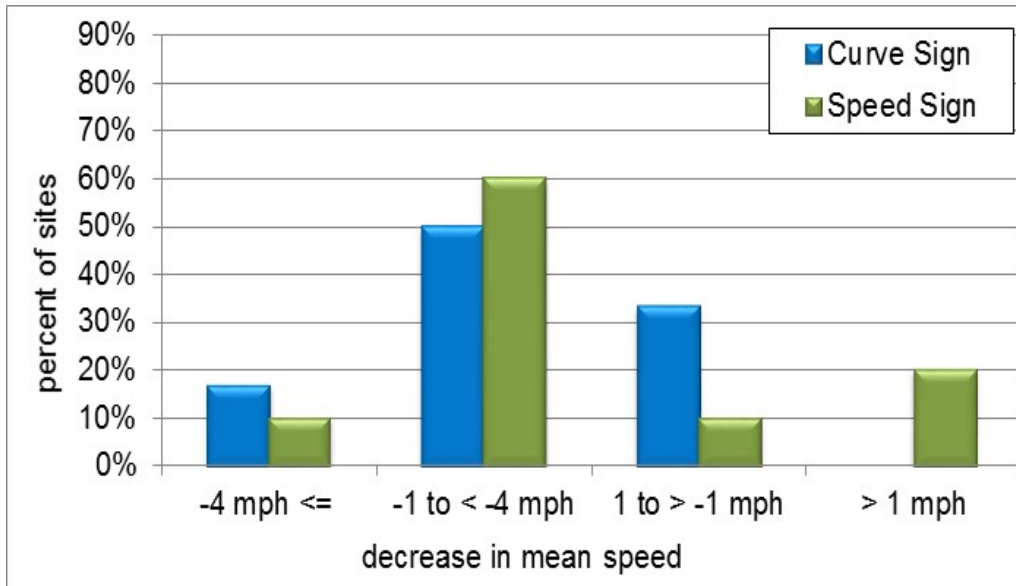
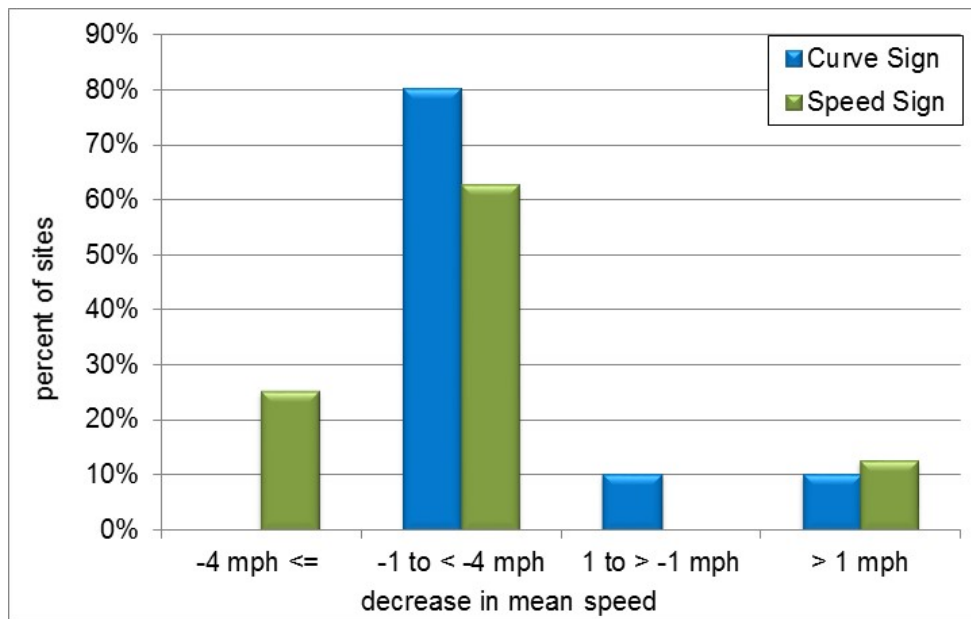
Figure 21 through figure 23 show information for mean speeds at the CC by sign type for 1 month, 12 months, and 24 months after installation of the signs.

Figure 21. Chart. Changes in mean speed at the CC by sign type about 1 month after sign installation.

Figure 22. Chart. Changes in mean speed at the CC by sign type about 12 months after sign installation.

Figure 23. Chart. Changes in mean speed at the CC by sign type about 24 months after sign installation.

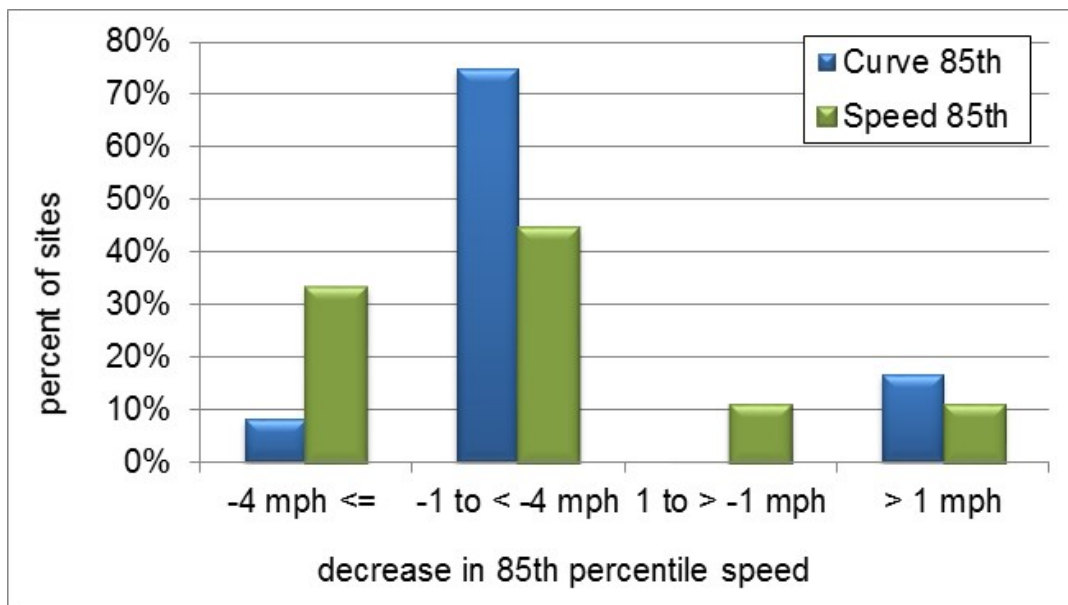
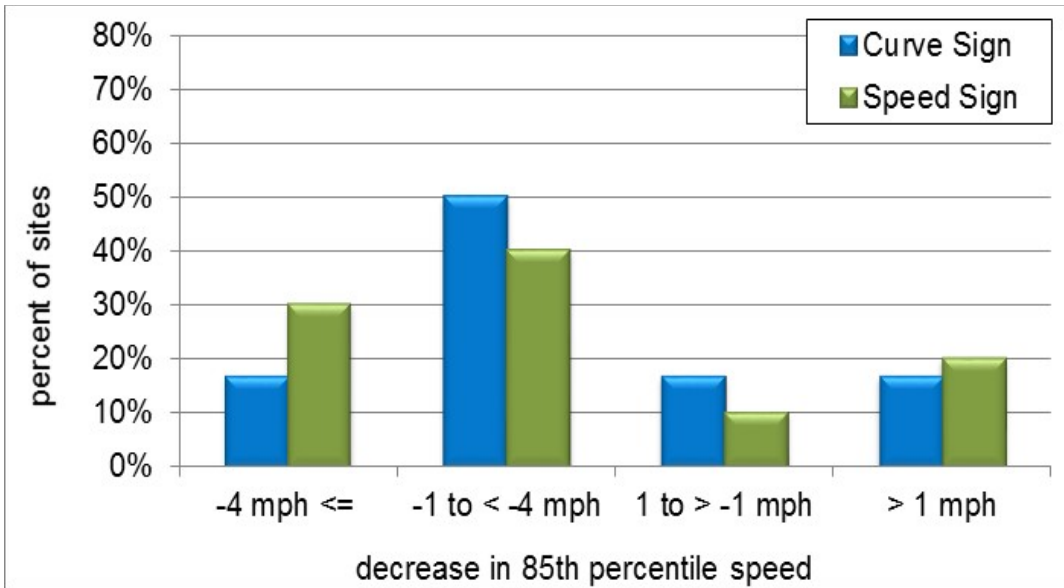
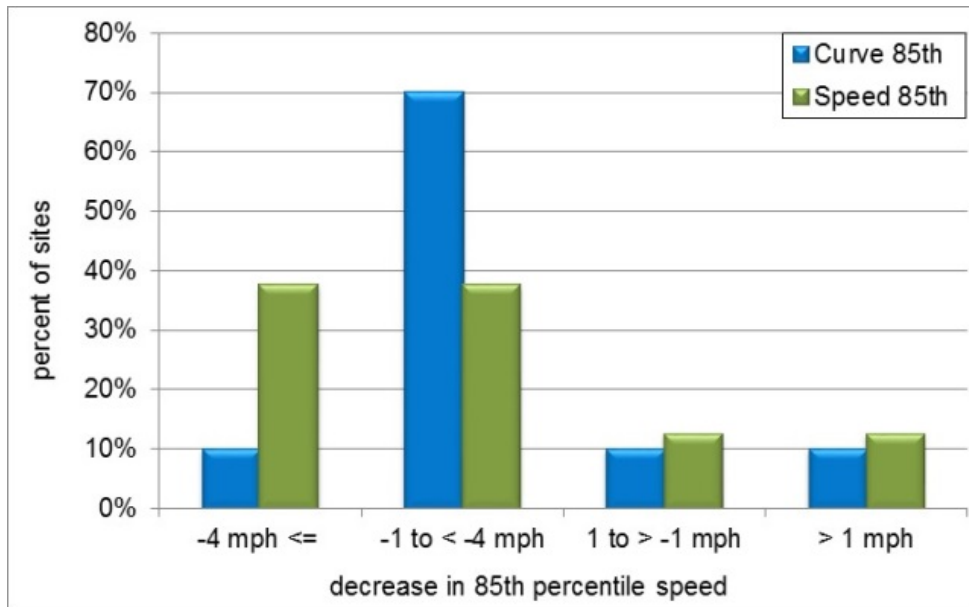
Differences in 85th percentile speeds between sign types for data collected at the CC are shown in figure 24 through figure 26 for 1, 12, and 24 months after installation of the signs.

Figure 24. Chart. Changes in 85th percentile speed at the CC by sign type about 1 month after sign installation.

Figure 25. Chart. Changes in 85th percentile speed at the CC by sign type about 12 months after sign installation.

Figure 26. Chart. Changes in 85th percentile speed at the CC by sign type about 24 months after sign installation.

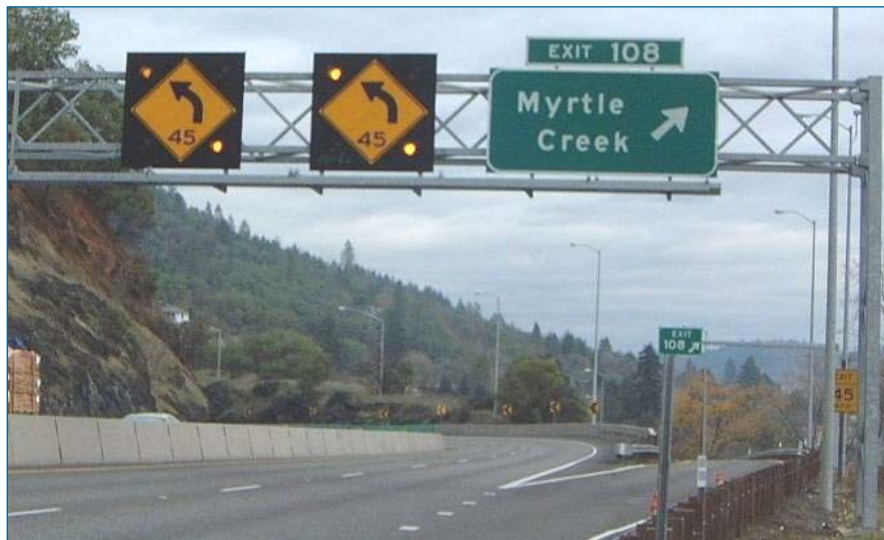
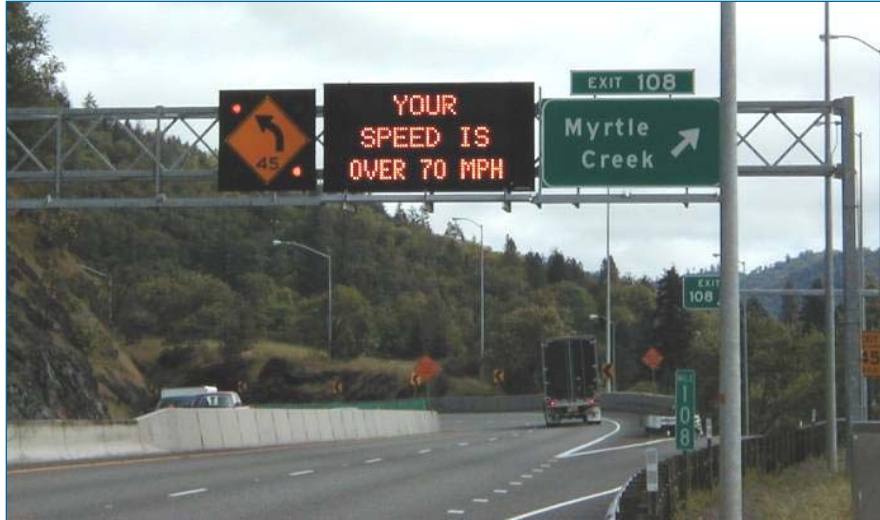
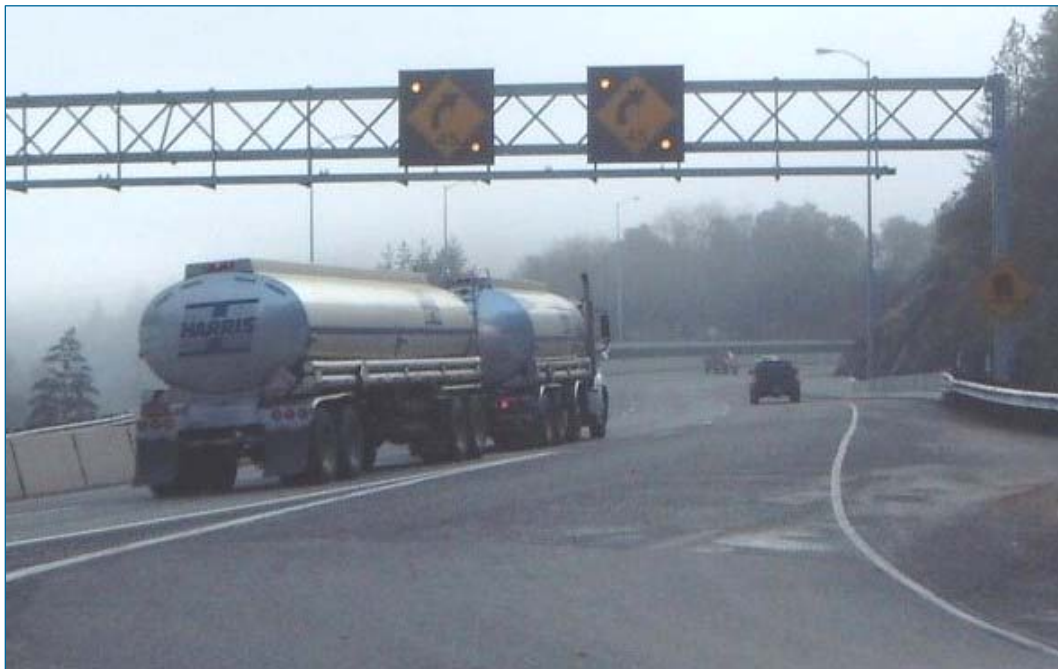
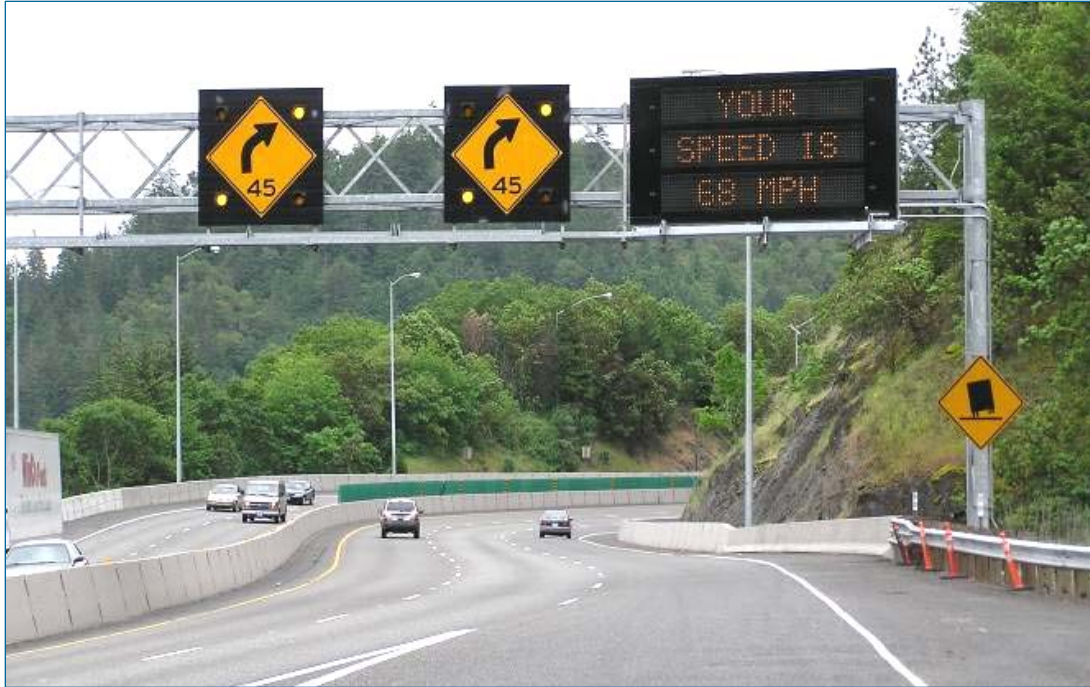
The curve has an advisory speed of 45 mph with an AADT of 16,750 vpd. Before the DSFS system was in place, there was what they termed “dual overhead horizontal alignment/advisory speed combination sign assemblies with four flashing beacons.” The DSFS system was put in place alongside one of the existing signs in both the northbound (NB) and southbound (SB) directions. Each system consisted of the actual dynamic message sign, a radar unit, a controller unit, and computer software. Figure 27 through figure 30 show the system.

Figure 27. Photo. Interstate 5 DSFS systems in Oregon (Northbound before).

Figure 28. Photo. Interstate 5 DSFS systems in Oregon (Northbound after).

Figure 29. Photo. Interstate 5 DSFS systems in Oregon (Southbound before).

Researchers collected speed data using a laser gun. Results indicated that, after installation of the DSFS system, passenger vehicle speeds were reduced by 2.6 mph and commercial truck speeds were reduced by 1.9 mph, with the results being statistically significant at the 95-percent confidence level. The distribution of speeds shifted to the left after installation of the signs, and the differences were found to be statistically significant based on a 95-percent confidence level using the chi-square test.

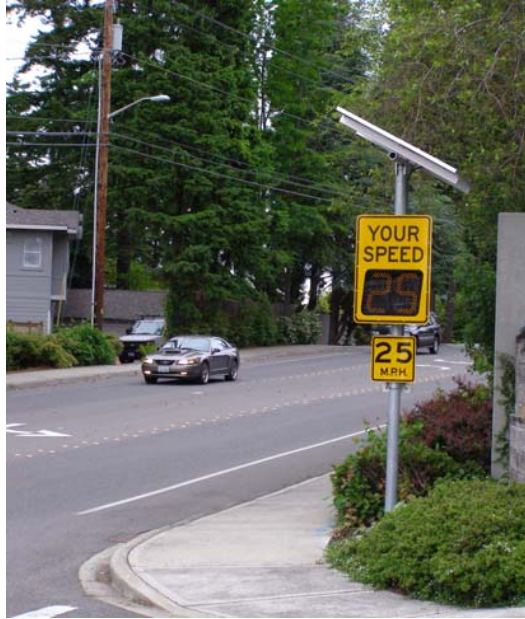
Figure 32. Photo. DSFS in Bellevue, WA.

The City of Bellevue, WA, installed and evaluated 31 DSFS systems, including two used as curve advisory warnings (figure 32). Both were on urban arterials with 35 mph speed limits and 25 mph advisory speeds. Speeds were collected before and between 18 months and 2 years after installation of the signs. One sign showed a 3.3 mph reduction in 85th percentile speed, and the other showed a 3.5 mph reduction.

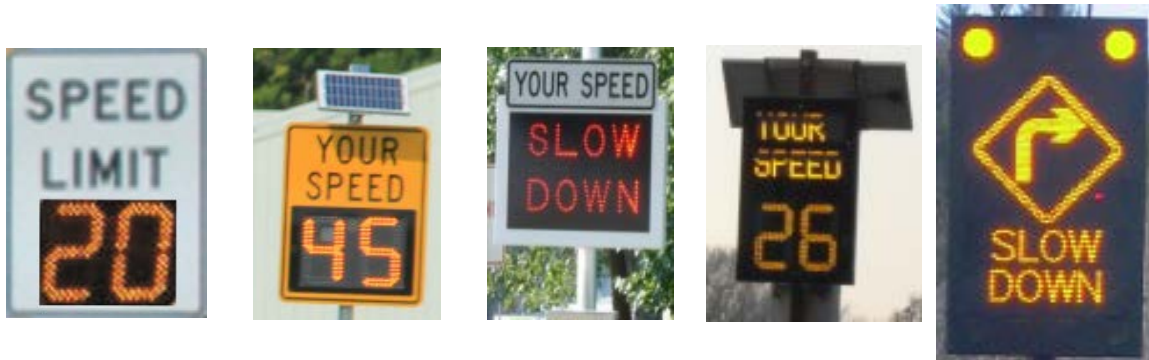
Figure 41. Photo. Types of dynamic speed-activated feedback signs.

Signs that met the minimum criteria were categorized by the sign message type. No DSFS systems were identified that had only a flashing beacon. Figure 41 shows signs that were categorized into one of four categories.
